A REPORT ON THE DECEMBER 2, 1994
WADAKKANCHERI EARTHQUAKE

Kusala Rajendran and C.P. Rajendran
Centre for Earth Science Studies
Trivandrum - 695 031

March, 1995

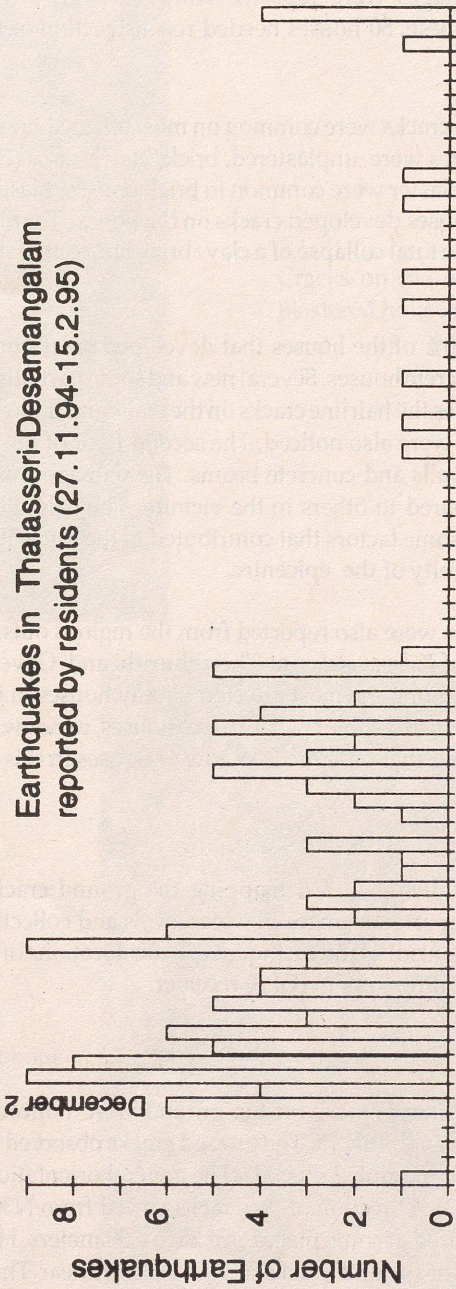
November 27, 1994 - February 15, 1995

Figure 2. Frequency of occurrence of earthquakes from November 27 to February 15.

In the absence of stations in the vicinity of the epicentre, the reports from the local residents were used in the time series analyses. Care has been taken to filter the data to avoid duplication because of possible errors in time. What we consider a reliable data set (up to February 15, 1995) is presented in Table 1. The time series is also shown in Figure 2.

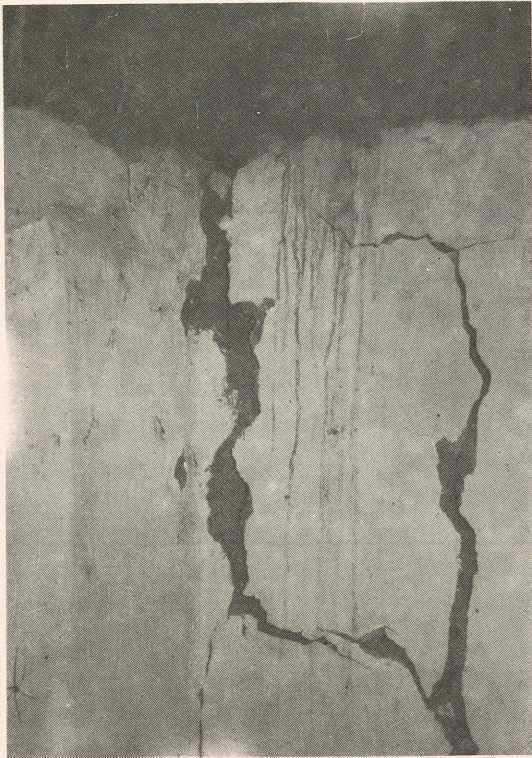
Cracks on the wall of a poorly plastered house near Mayannur.

Hairline cracks were common on most affected houses. Nearly 90% of the houses that suffered damages were unplastered, brick/clay houses (Photograph 1, Plate I). Incidence of fallen/broken plaster were common to brick houses, plastered with low quantity of cement. Several such houses developed cracks on the floors. There were reports of partial collapse of some house. The total collapse of a clay/brick house at Mayannur was the most significant of such instances.

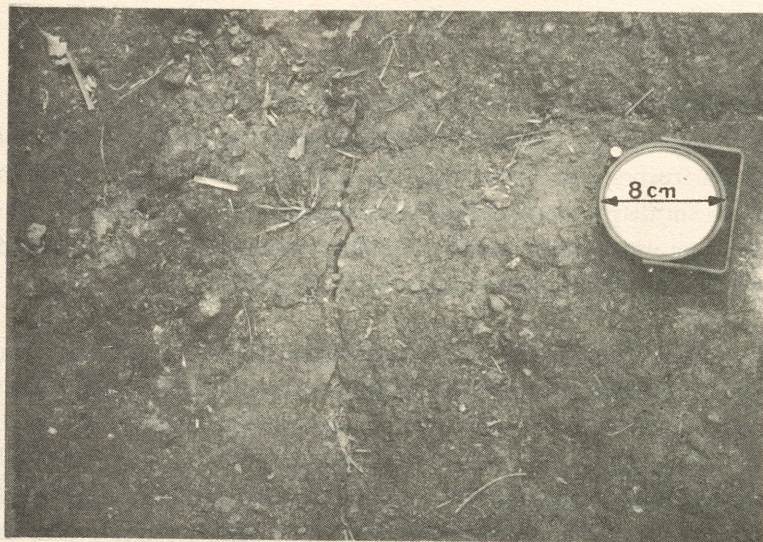
Ground cracks observed near Thalasseri.

Several linear cracks on the ground were noticed at some locations in Thalasseri, Varavur and Arangottukara. The ground cracks observed at various locations were less than 2 mm wide (Photograph 2, Plate I). The general orientation of the cracks was in ENE to EW direction (Fig. 3). Direction of the cracks varied from N30° to N80°. The depth of the crack could be measured at some places as 0.25 to 0.50 meters. However a trial pit taken across one of the prominent ground cracks at Kadukasseri near Thalasseri did not reveal any useful information regarding the ground breakage. The one-metre-deep trench exposed purely shallow and superficial nature of the ground cracks. It was noted that these cracks, although related to the tremors, were mostly confined to the loose soil and some developed in the areas of land-fill.

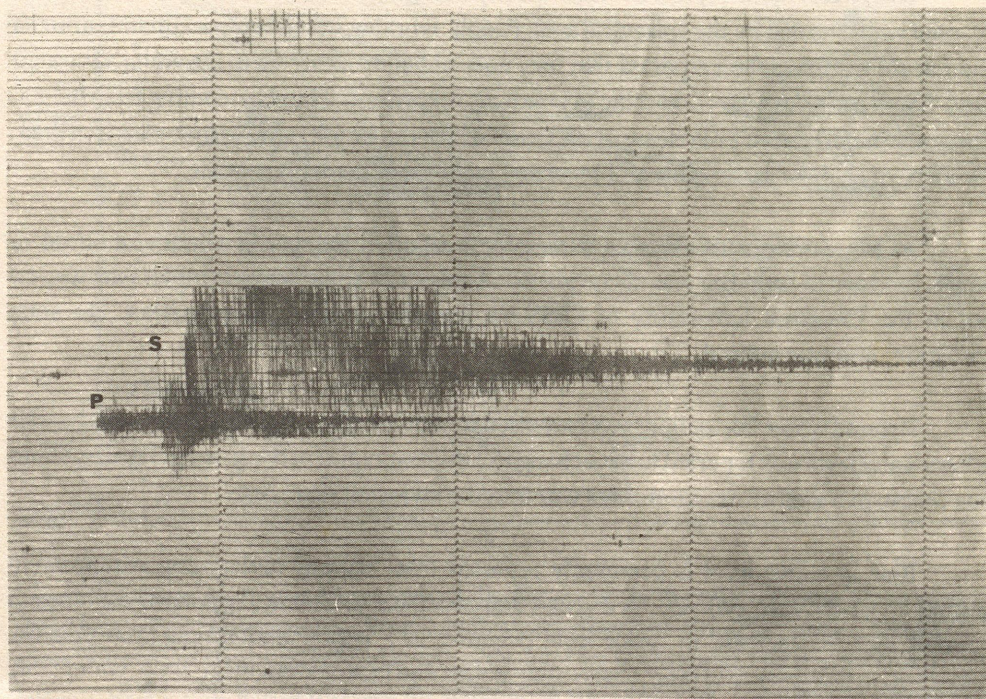
Record of the December 2 Wadakkancheri earthquake at Idukki observatory (source : KSEB)

The December 2 tremor was recorded by the seismic stations of NGRI, BARC, IMD and KSEB. Only the larger ones have been recorded by these stations. The Wadakkancheri main shock on Dec 2 (4:05 p.m. local time) was recorded by all the stations of the Idukki-Idamalayar nets (Table 2). The trace of the event as recorded by Idukki station is reproduced in Photograph 4 (Plate IV). The use of P and S arrival times of different stations are used in locating an earthquake is given in the Appendix II

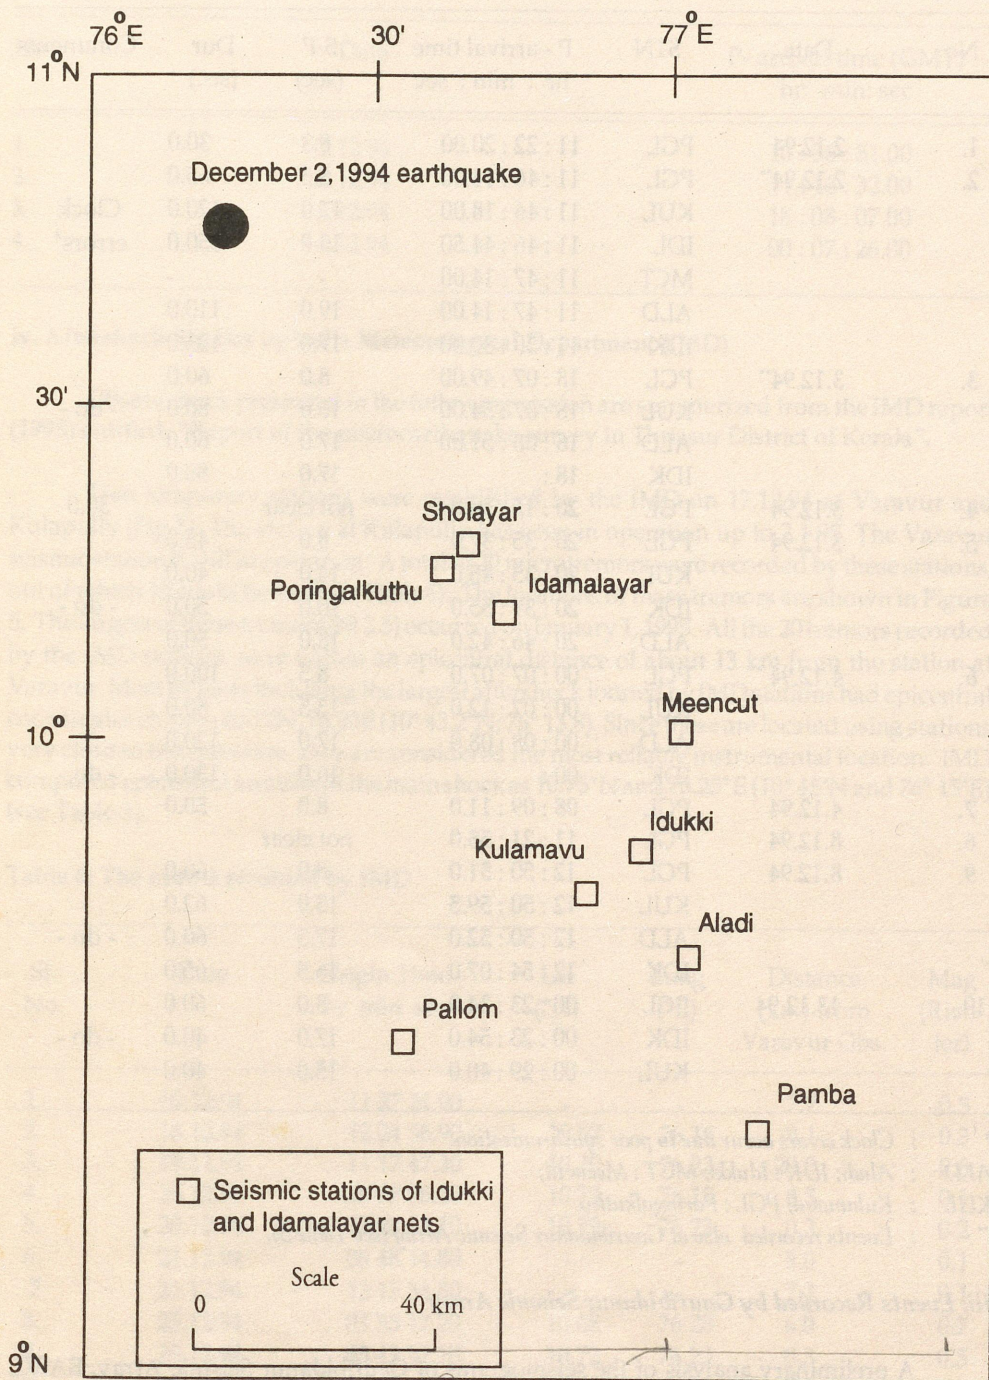
Figure 4. Azimuthal coverage of stations that recorded the December 2 earthquake.

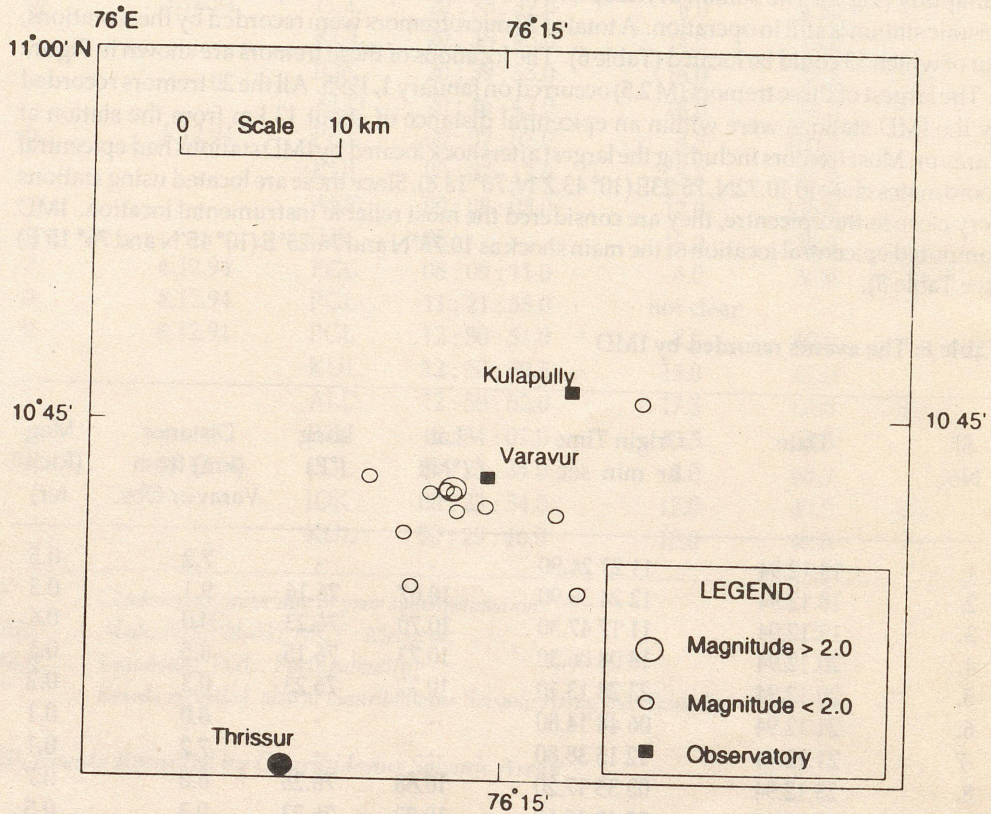
Figure 5. Epicentral coordinates of earthquakes from 18.12.94 to 05.01.95 (modified from IMD Report, 1995)

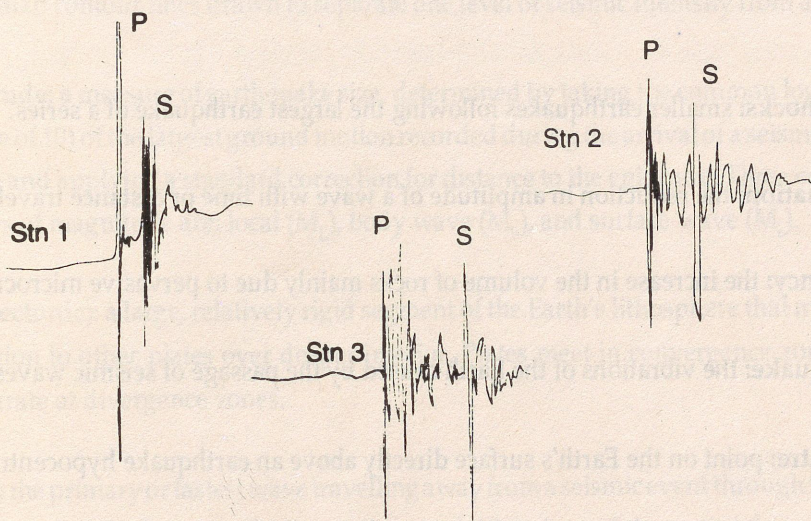
A Schematic figure showing how stations at various distances record the same earthquake. The differences in the arrivals of P and S waves at various stations are used to calculate the approximate distance to the epicentre. In the example, Stn 1 is closest to the epicentre. Using three or more such arrivals, an earthquake can be located by taking the point of concurrence of arcs drawn from each station, with radii proportional to the distance (time). 1 second is approximately equal to 8 km.
